TEMPORARY REVISION NUMBER 7

DATED 1 DECEMBER 2011

MANUAL TITLE Model 188 & T188 Series 1966 Thru 1984 Service Manual
MANUAL NUMBER - PAPER COPY D2054-1-13
TEMPORARY REVISION NUMBER D2054-1TR7

1. To add the Supplemental Inspection Documents (SIDs) Information.
2. To add the Corrosion Prevention and Control Program (CPCP) Information.
3. To add Control Cable Inspection Information.

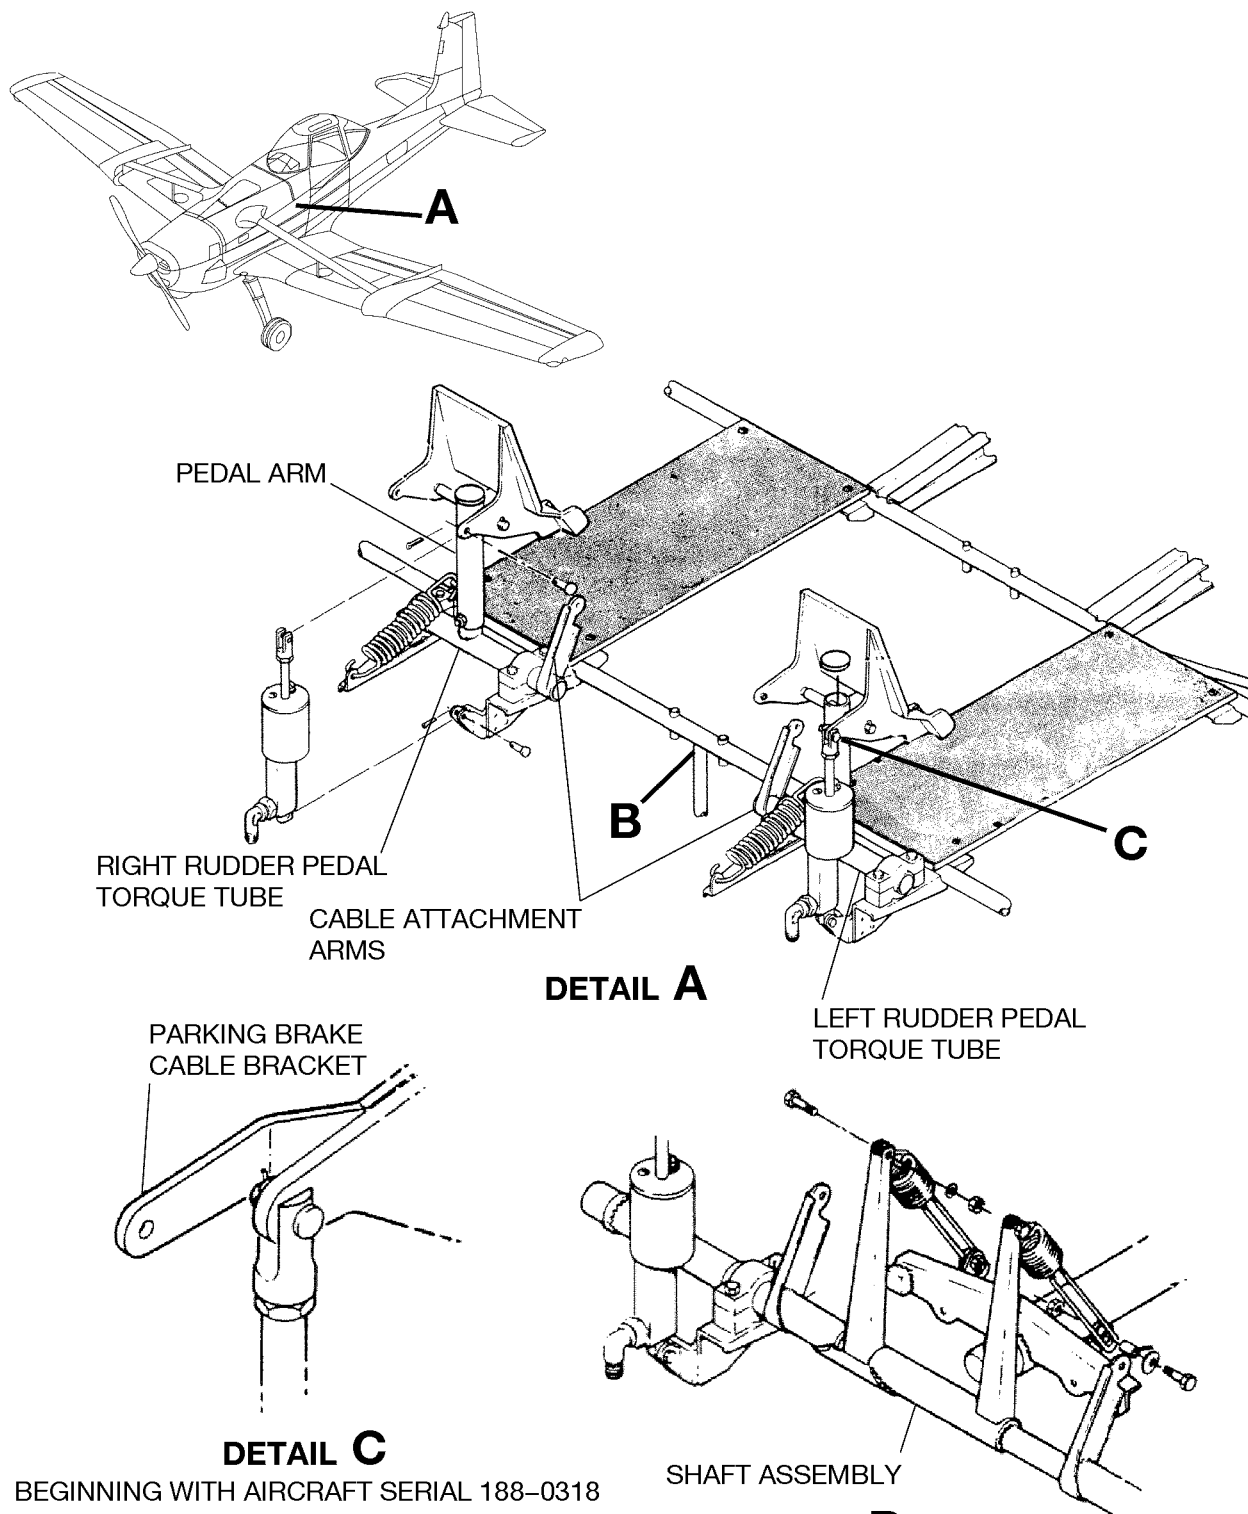
ACCESS/LOCATION	DETECTABLE CRACK SIZE
Fuselage, Near Forward Firewall	Not Allowed

7. REPAIR/MODIFICATION
Typical failures occur at or close to welds in the rudder bar. Since the rudder bar is not heat treated after welding, it can be rewelded and used without subsequent heat treatment. Examine the rewelded area after welding for any new or additional cracking. Repairs may be made in accordance with Section 17 (Structural Repair) of the Model 188 Service Manual. Coordinate any repair not available in Section 17 with Cessna Customer Service prior to beginning the repair.

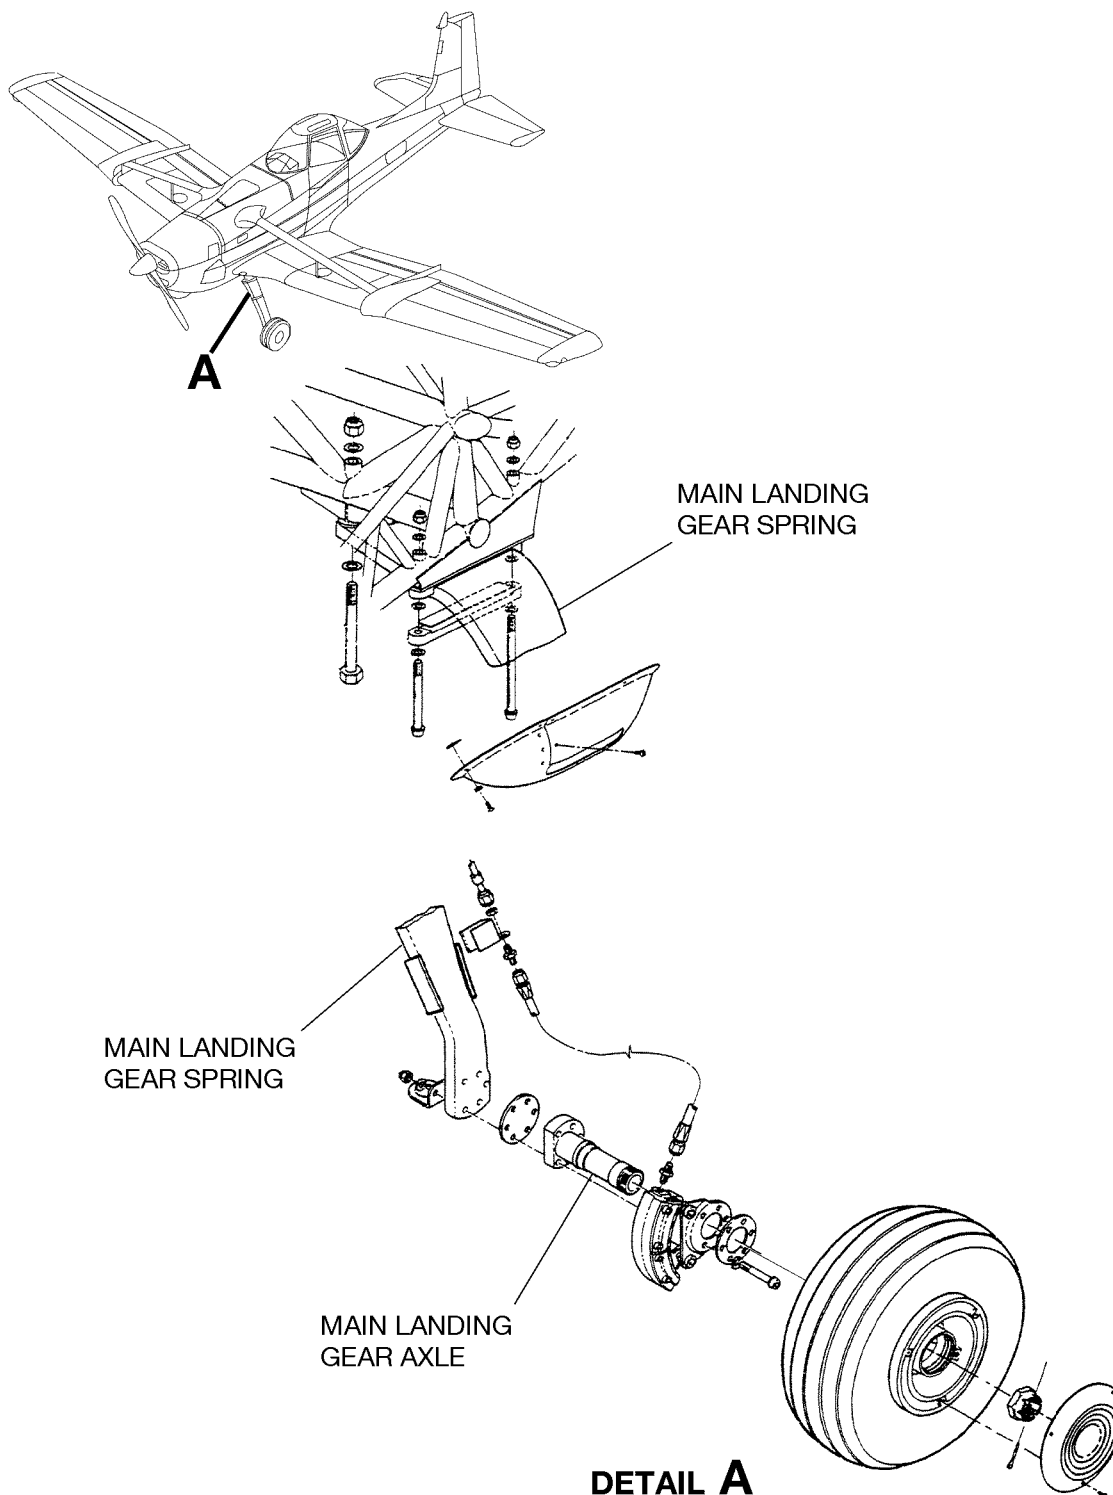
- A. If corrosion has developed on the flat spring landing gear, it must be removed before refinishing. The recommended procedure to remove corrosion is by hand sanding, using a fine grained sandpaper.

CAUTION: Do not use chemical paint strippers. Some chemical strippers are acidic and can produce hydrogen. The springs are high heat treated steel, which is subject to hydrogen embrittlement if exposed to hydrogen. Hydrogen embrittlement can cause delayed failure.

- B. Refer to the Model 188 Maintenance Manual, Section 5-5A, for detailed instructions on corrosion removal on the gear springs and axle.
- C. Refinish sanded areas.

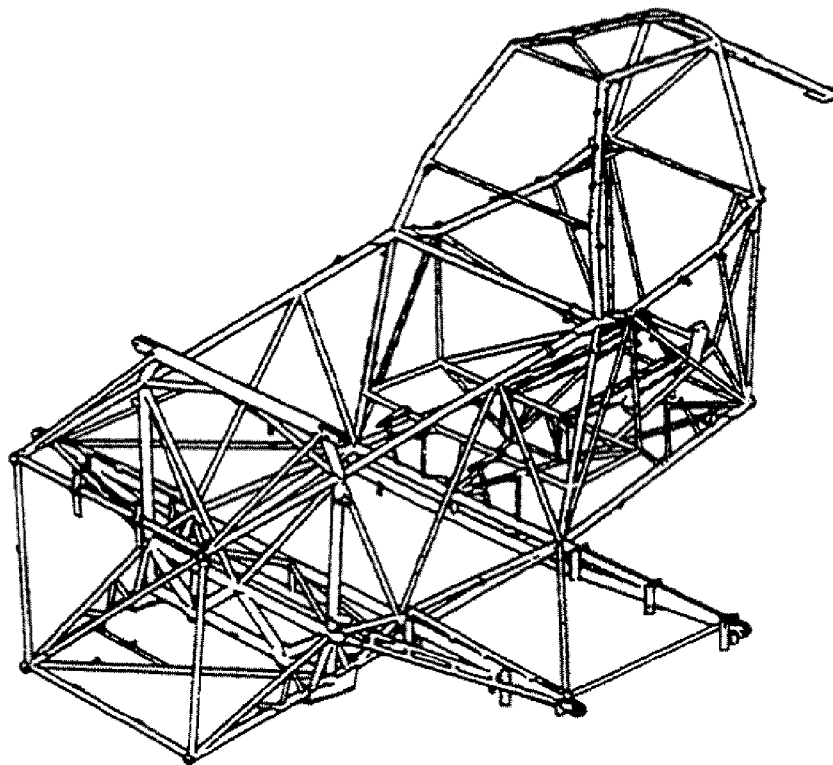
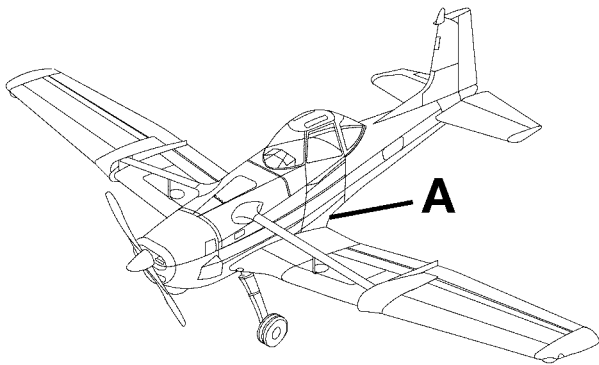
Visual and Surface Eddy Current to confirm any suspected cracks.

- A. If rust has developed on the tubular fuselage structure, it must be removed. The recommended procedure to remove rust is by hand sanding, using a fine grained sandpaper.

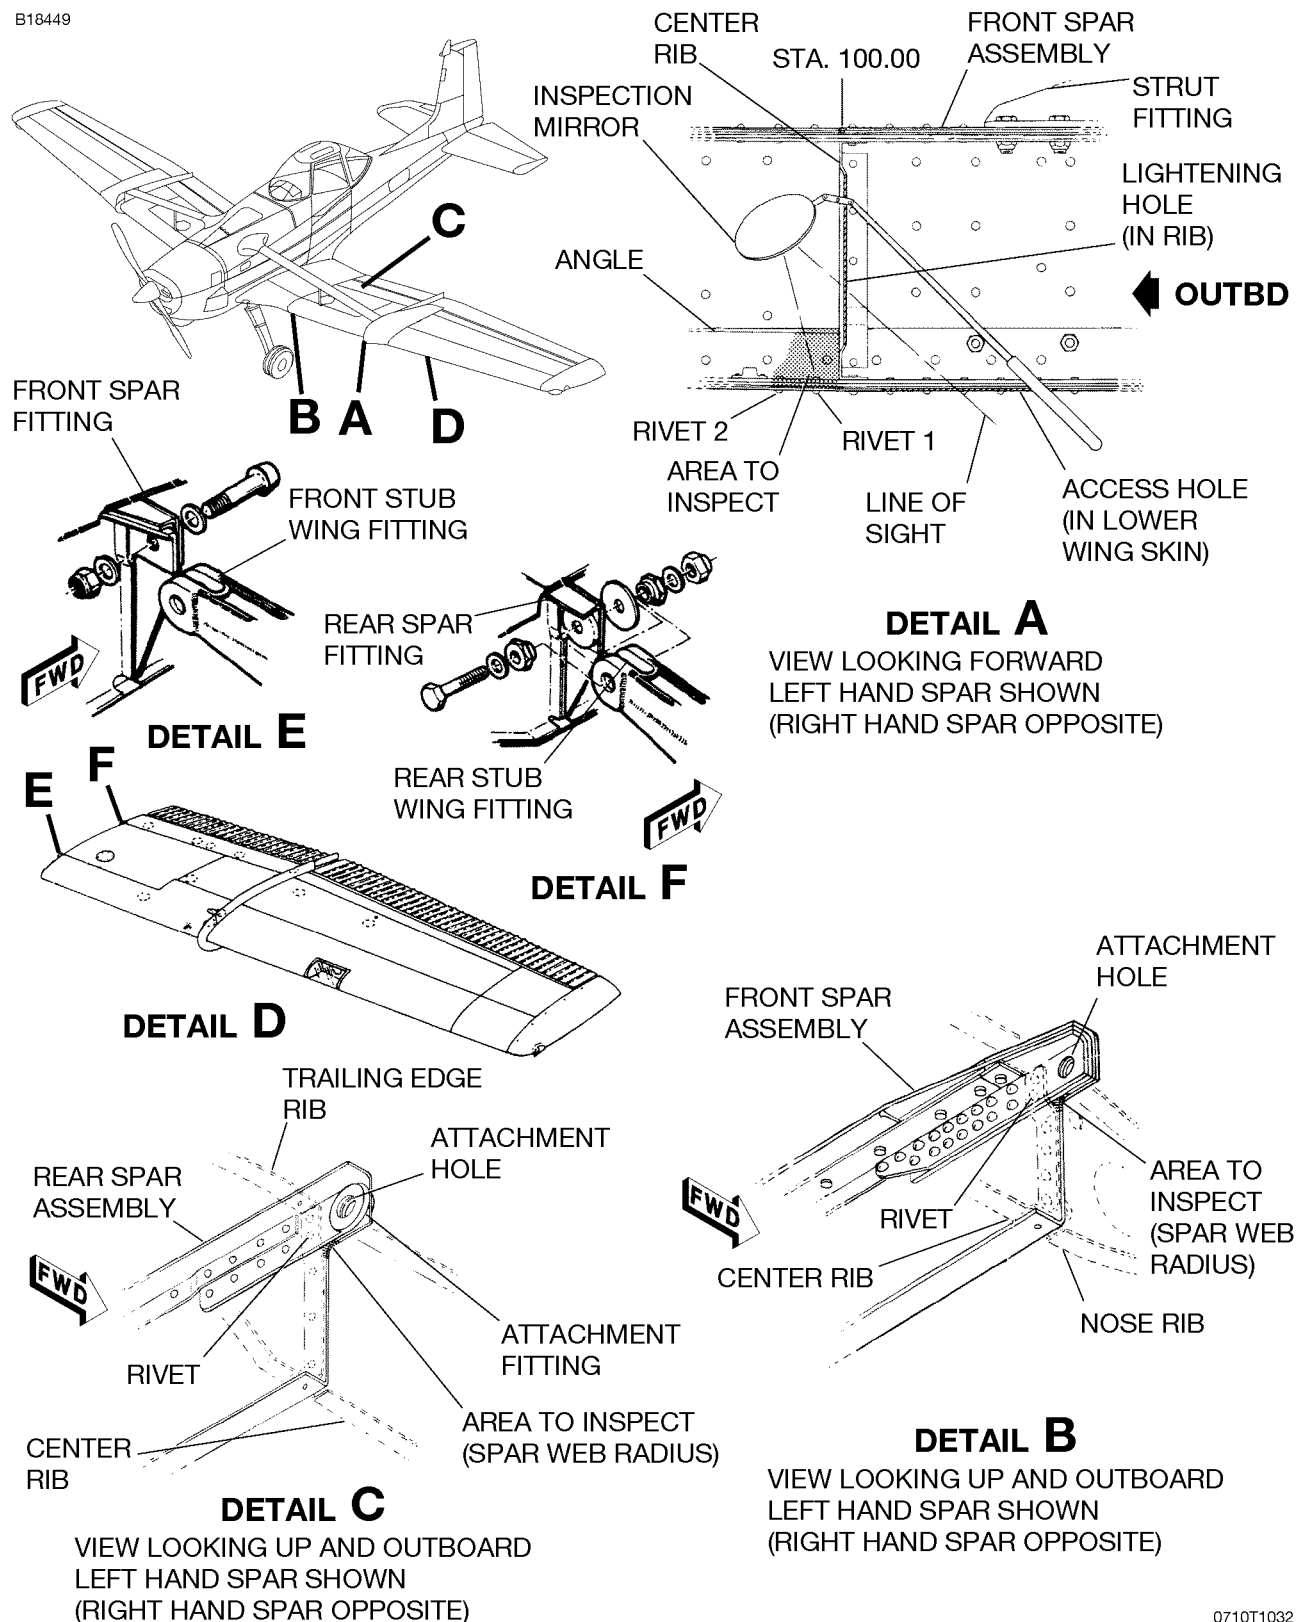
Visual, Eddy Current, Borescope, Magnifying Glass

Replace cracked or excessively corroded parts. If corrosion is present, it must be removed before refinishing. Contact Customer Service for assistance prior to beginning the repair if the disassembly exceeds the repair facilities experience or capability.

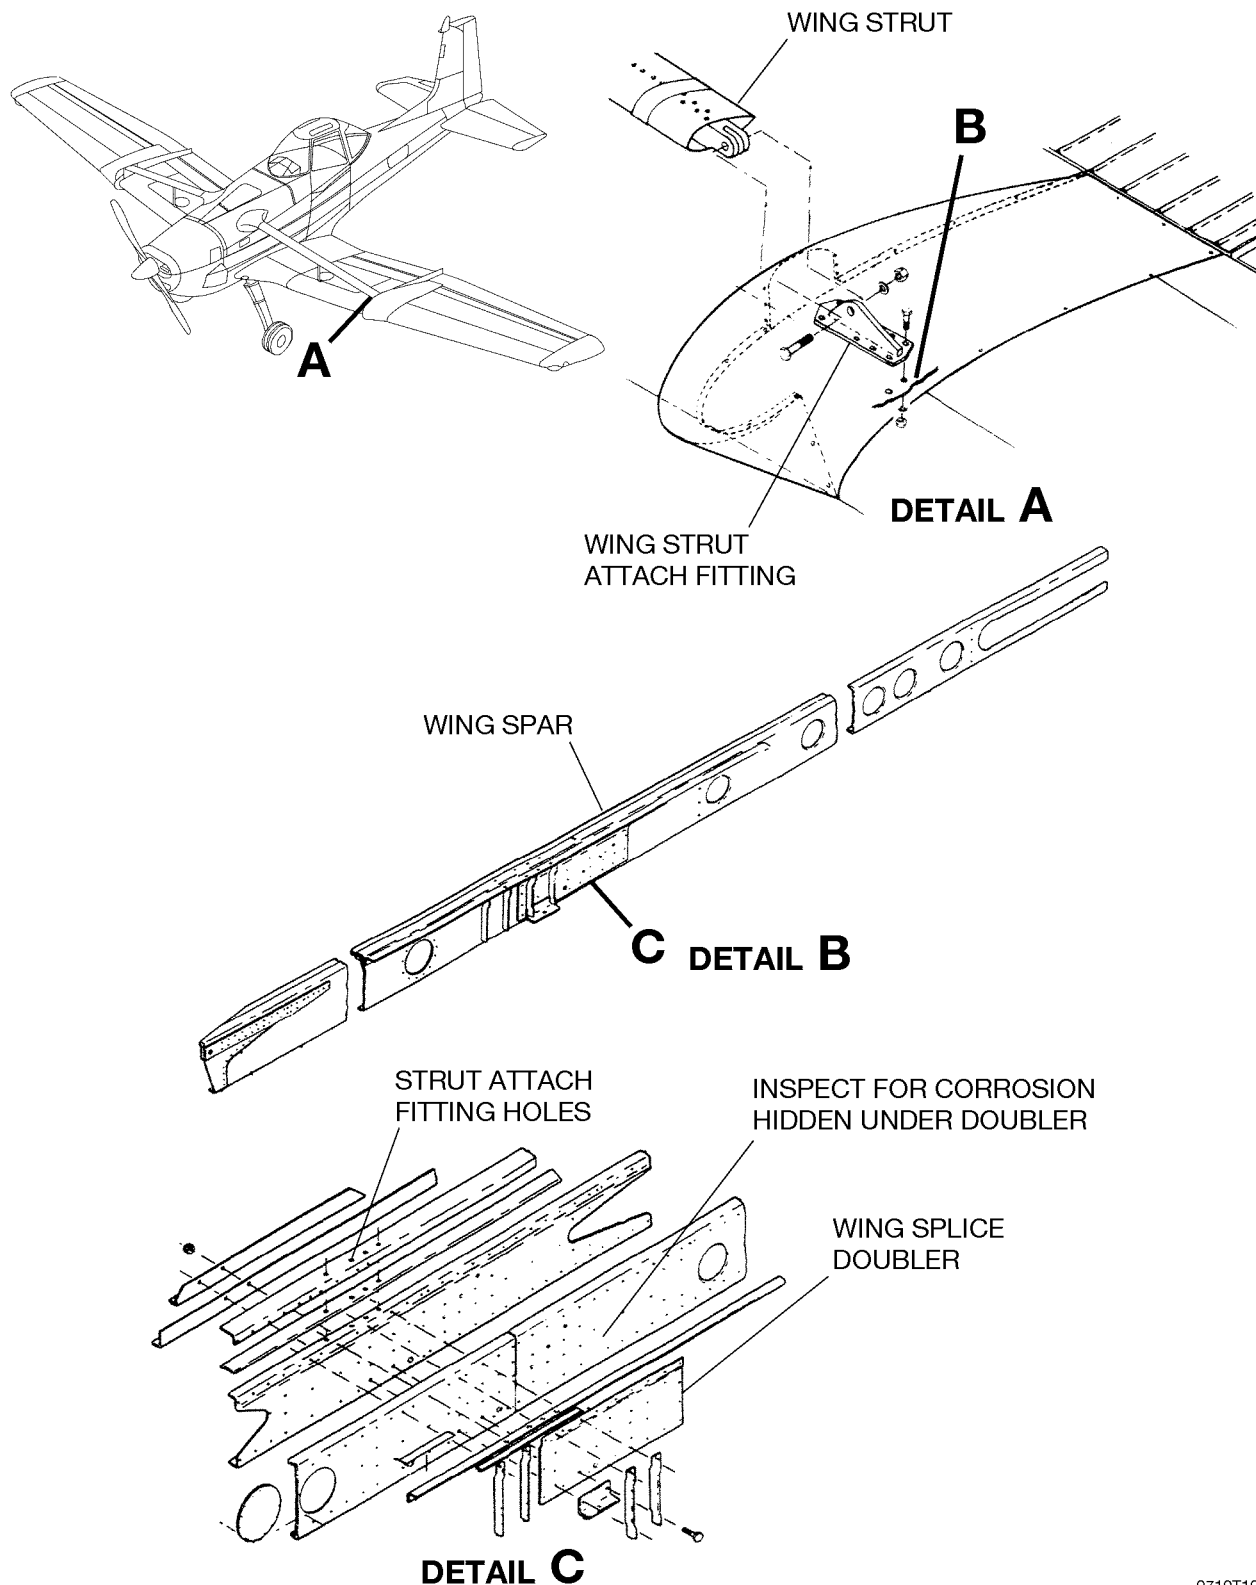
6. INSPECTION METHOD
Visual, Ultrasonic Thickness, Eddy Current

Replace any cracked parts. If corroded, sand area lightly to remove corrosion. If more than 10% of the thickness has been removed in any one area, replace the part.

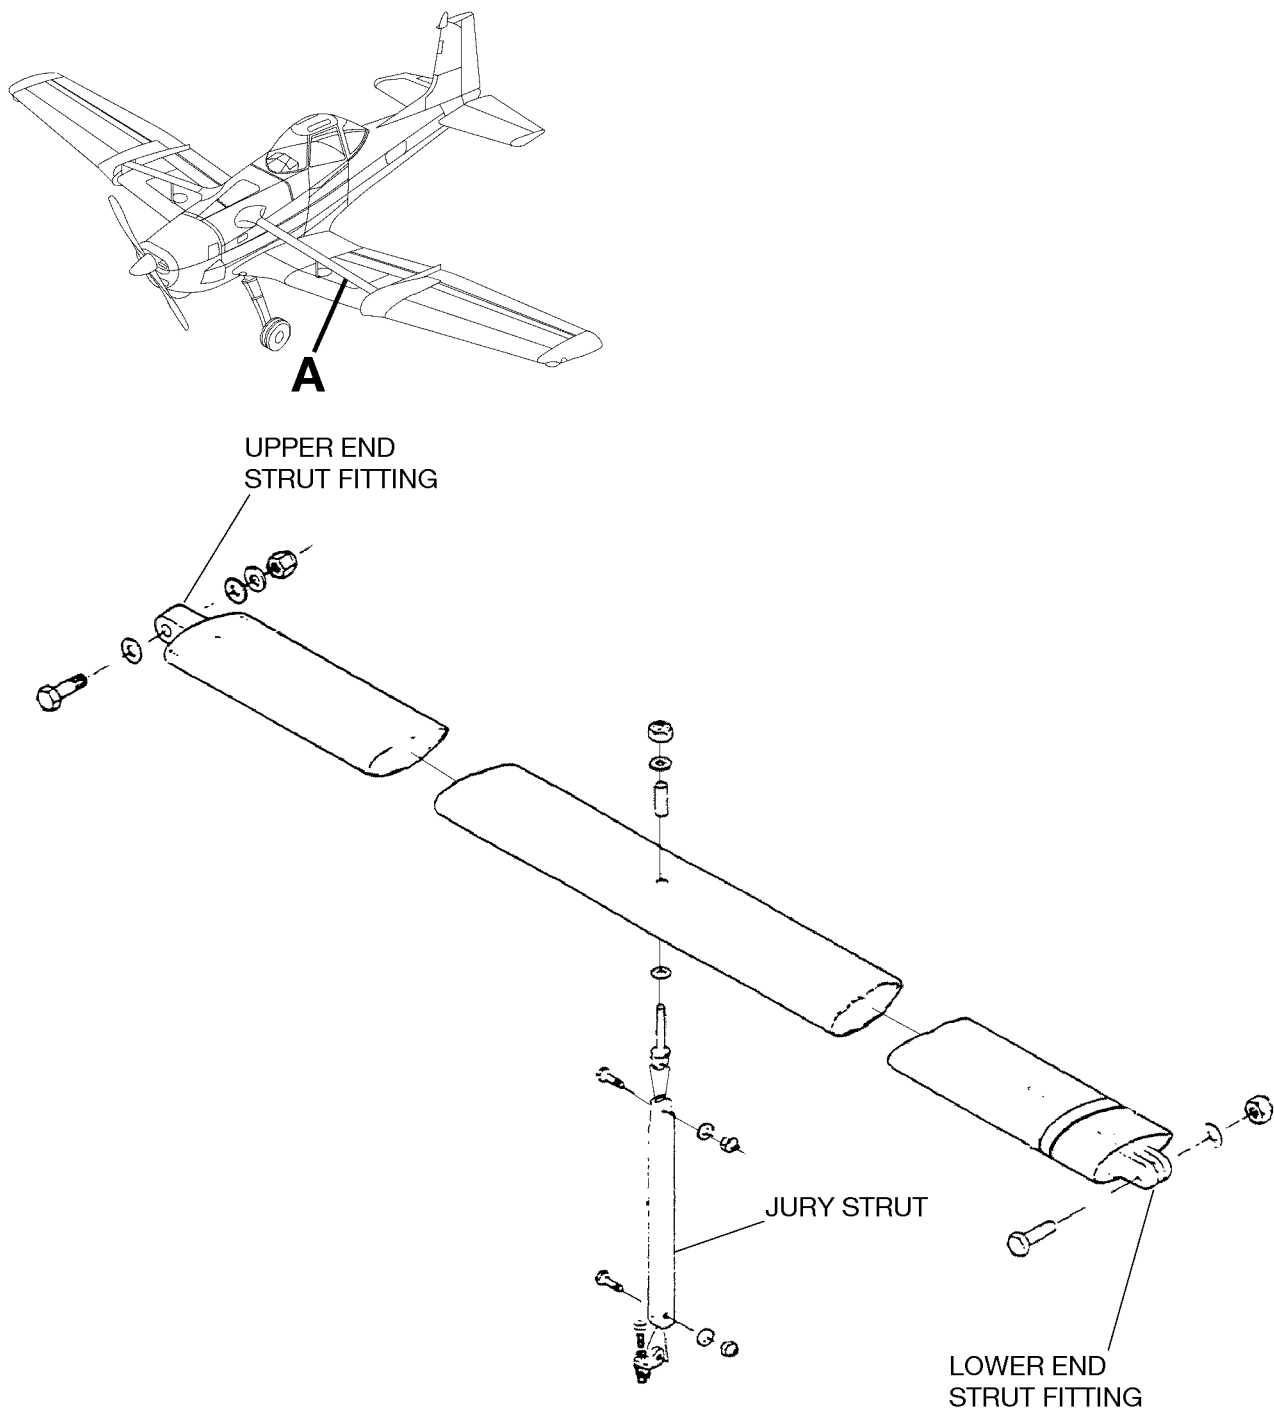
Visual and Eddy Current

- A. If corrosion is found, remove corrosion by lightly sanding corroded area, taking care to remove as little material as necessary to completely remove corrosion. If the material thickness is less than 90% of the uncorroded section, then replace the affected part.
- B. Buff out sanding marks.
- C. Corrosion or damage to attachment holes will require specialized rework. Contact Cessna Field Service for rework of corroded or damaged attachment holes.
- D. Clean and prime sanded areas.

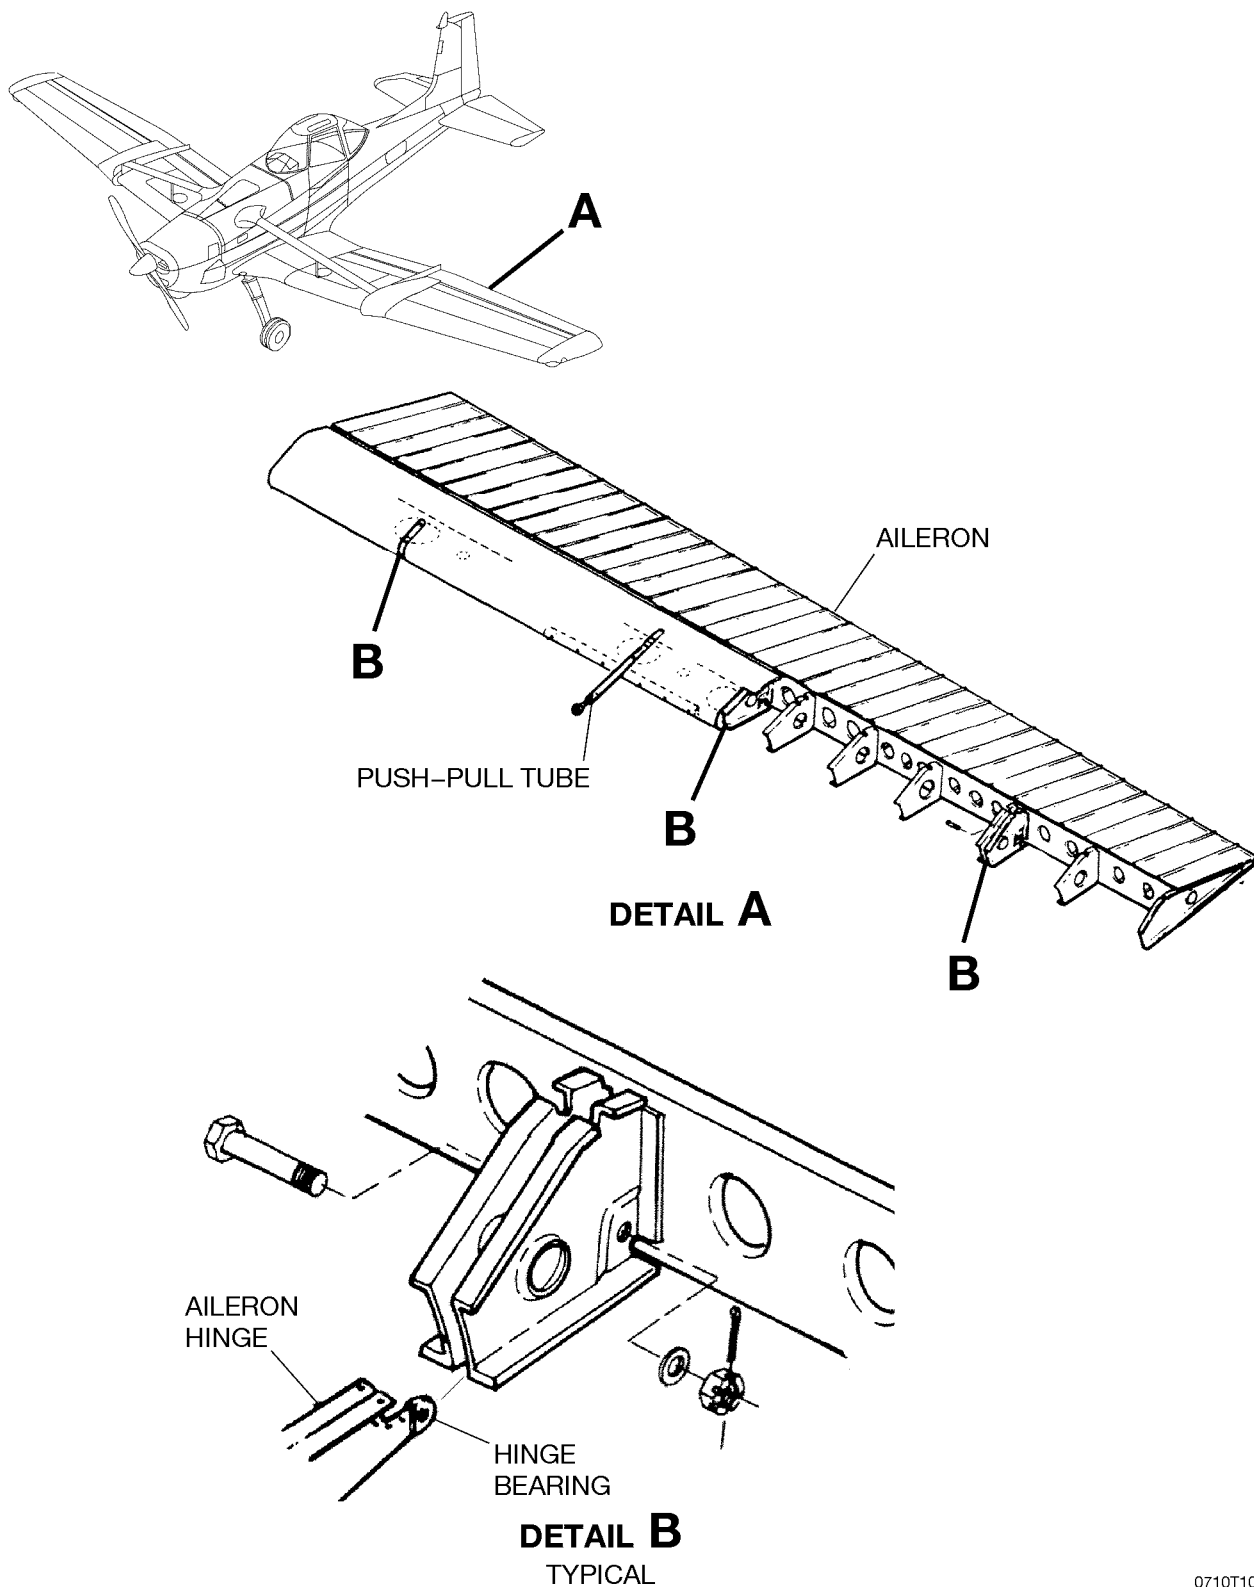
6. INSPECTION METHOD
Visual and Eddy Current

7. REPAIR/MODIFICATION
Replace any damaged or cracked fittings. Replace damaged hinge bolts. Replace loose, corroded or tight bearings. Repairs may be made in accordance with Section 17 of the Model 188 Service Manual. Any repair not available in Section 17 should be coordinated with Cessna Customer Service prior to beginning the repair.

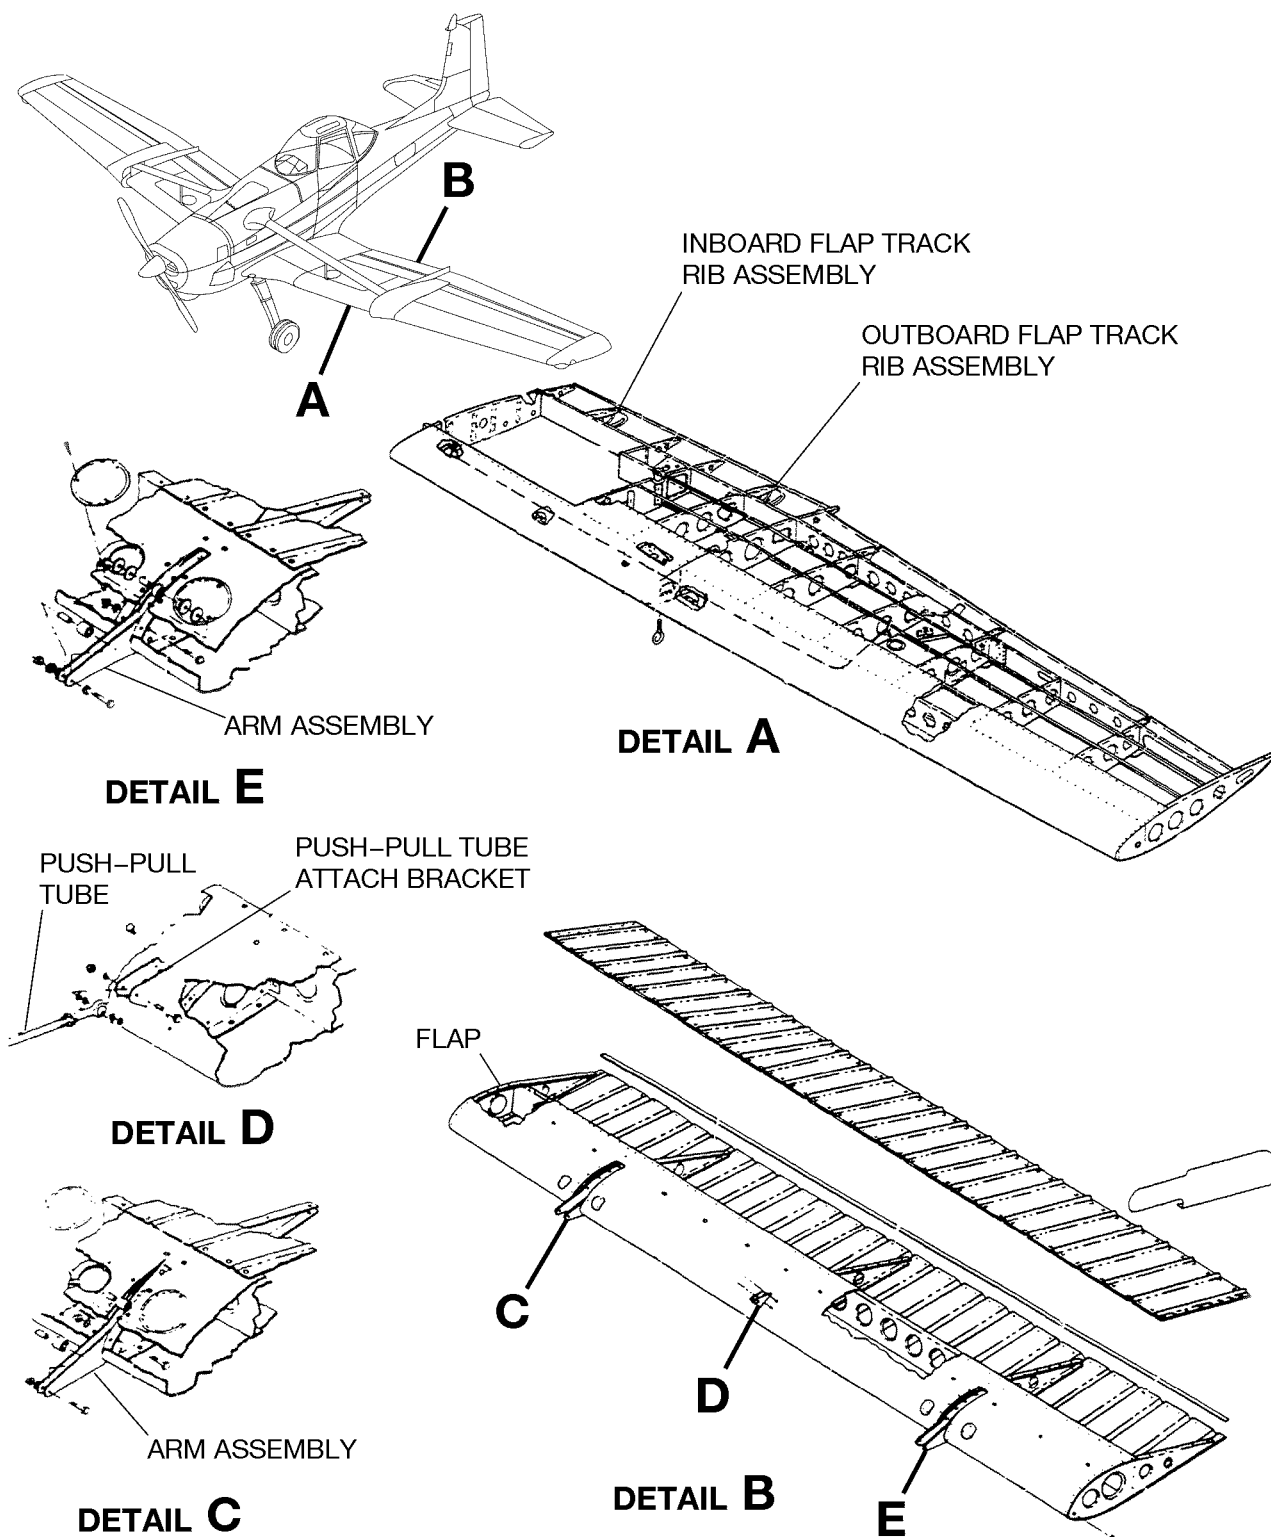
Visual

Replace damaged or loose rivets. Replace damaged flap tracks or attachments.

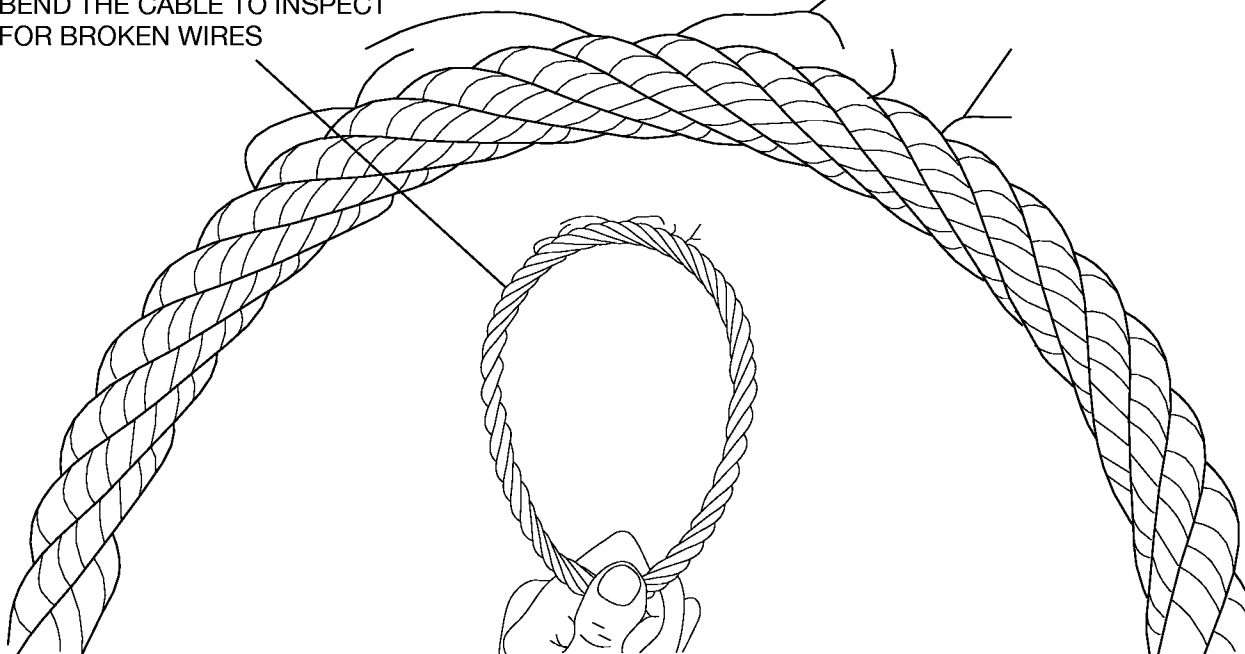
BROKEN WIRE FOUND VISUALLY WHEN THE CABLE WAS REMOVED AND BENT

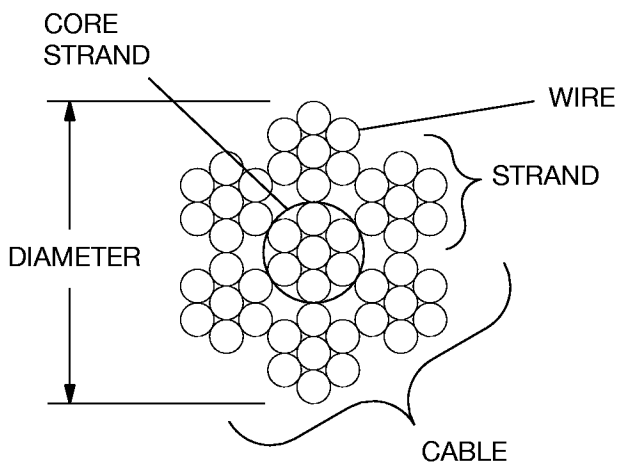
Cable Broken Wires and Pulley Wear Patterns
 Figure 1 (Sheet 1)

DO NOT BEND THE CABLE INTO A LOOP SMALLER THAN 50 CABLE DIAMETERS
